# DAC90a Number Three.

This was another local auction purchase. Despite already having two I wanted to do this as it had a broken case which would be an interesting change. It was also a later version that my others.

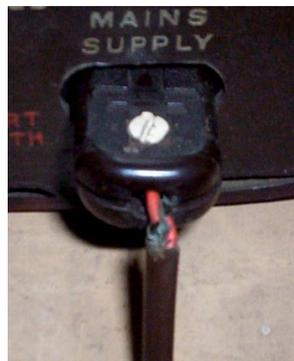
The wiring is in a bit of a state.

I took the chassis out and noticed that the voltage selector was on 210V. The top bit of the dropper looked very dark and I expected it to be o/c and then somebody had re-set the voltage selector to by-pass the damaged bit. It seemed OK so I put that up to 250V. I then changed the AF coupler and, after checking none of the balding wires were touching, gave it some juice. Nothing seemed to be happening but I then saw faint glows through the muck on the valves. I also saw that the lamp limiter was getting unhealthily bright. I then remembered that I hadn't snipped the filter. This looked like it had already spewed it's guts at some stage and after chopping its wire it played quite happily.

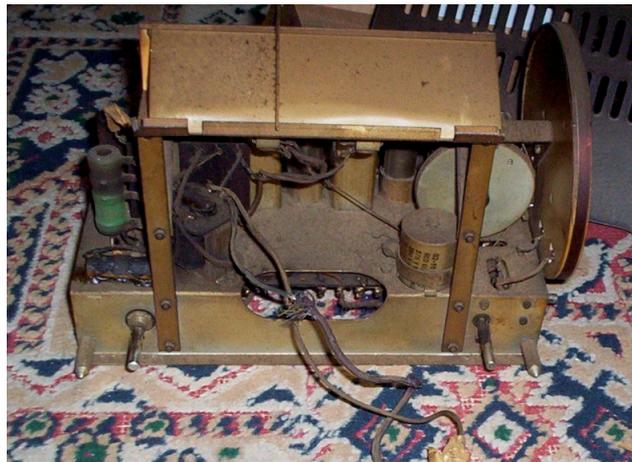
The extra sockets on the back weren't connected to anything. The speaker leads had been extended but it must have been done some time ago as they'd had time to go crispy.

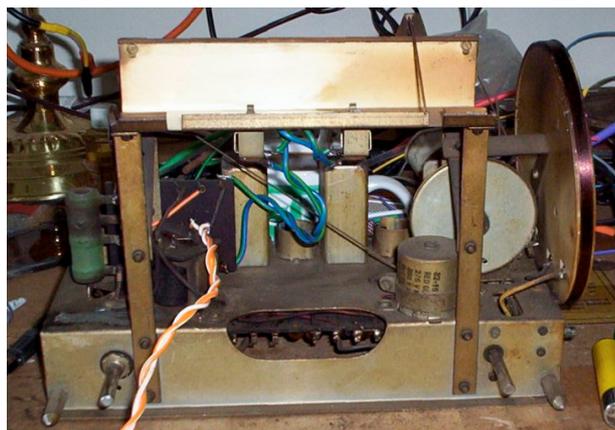
I then washed the case did the re-wiring. The photo shows the light-box half cleaned to show the contrast.

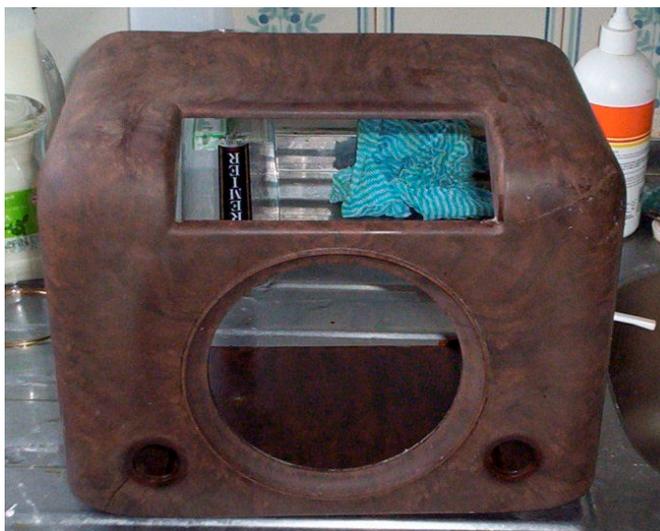
I gave the case a good wash and, as expected, it looked much worse afterwards.

When it had properly dried I stuck it back together with epoxy and clamped it up while it cured.

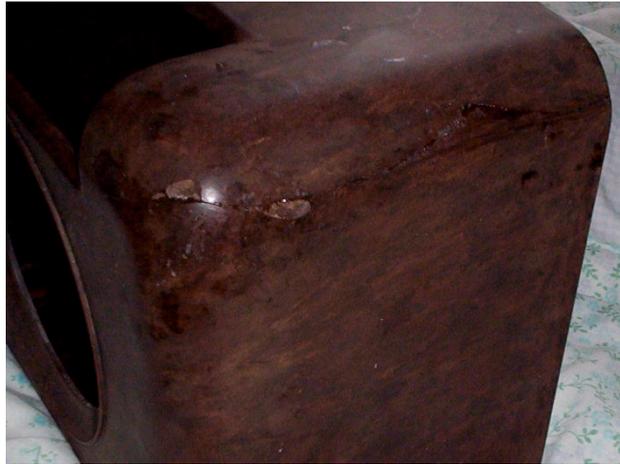
The next job was filling the chips.

I rubbed some wood on rough glass-paper, across the grain so the resulting dust was quite fibrous. I then stained that and left it to dry.

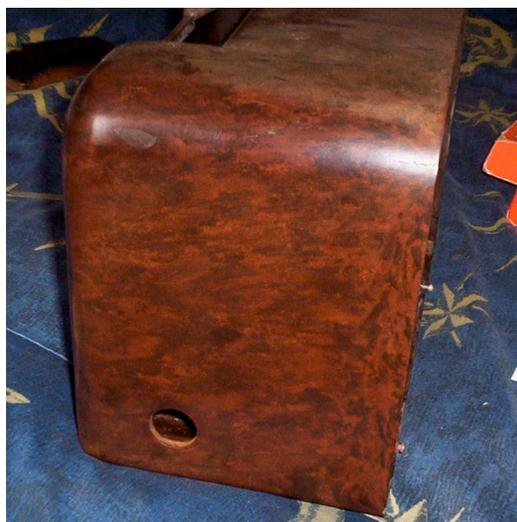
I then mixed that with epoxy and used this as a filler.

The colour-match wasn't great but I hoped it would improve with polishing.

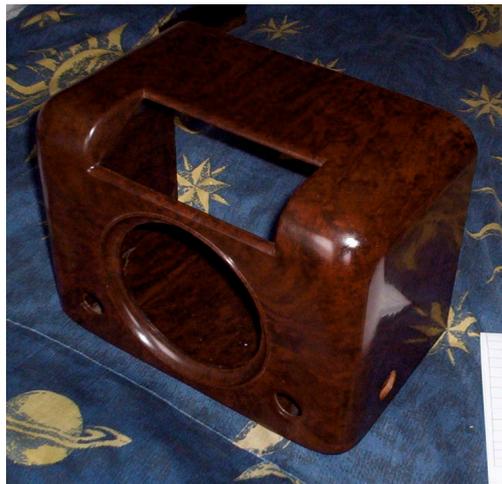
There was also a crack along the bottom edge but as this was out of site I only glued that and then gave it a good polish.

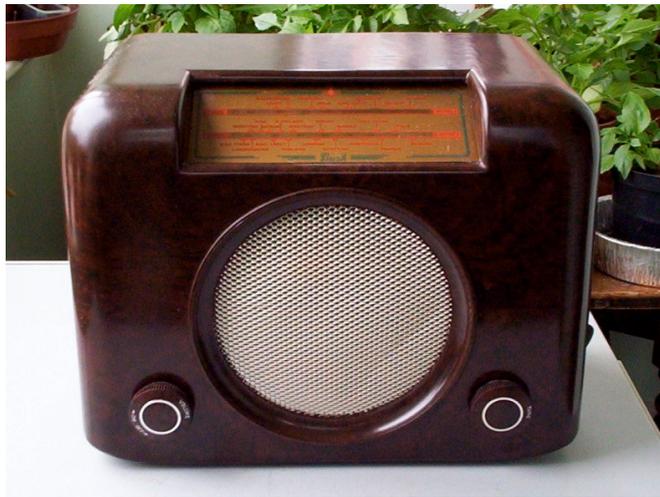
The other thing which is obviously 'wrong' with this set is the Perspex trims from around the knobs, which are a different type to the earlier versions, are missing. There's nothing remaining of them, not even old glue, but I prefer the look of the knobs without this adornment so will not be looking to replace them.
