# Roberts RT-1 Restoration

This radio came along with an Ultra U930 from a local auction. Despite being different technologies, though only four years apart, their restoration paths were quite similar.

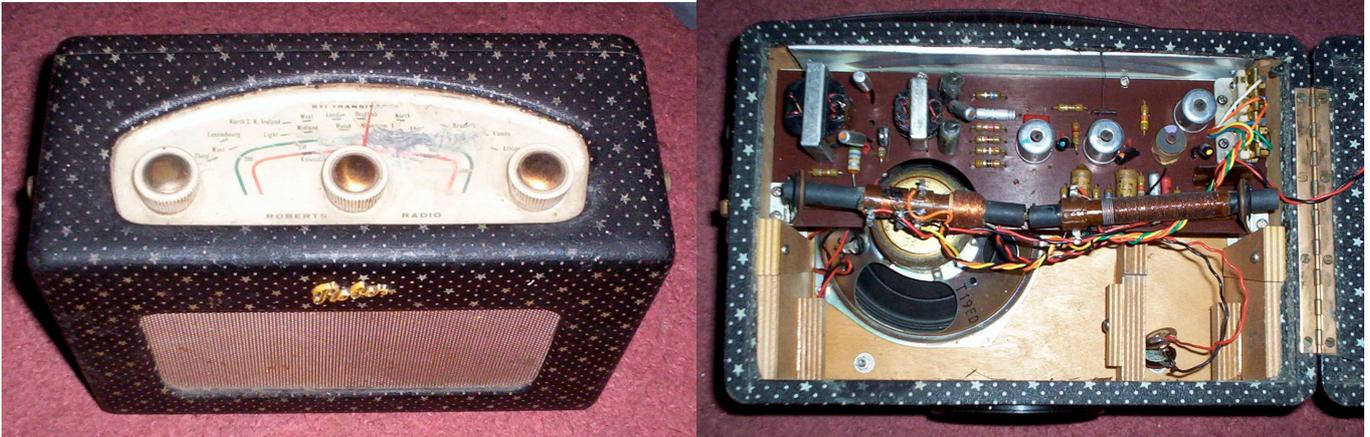
It was immediately apparent that the ferrite rod was broken and besides that it just plain didn't work. There was enough noise coming from it to show that there was at least life within the beast and there were neither AF11x transistors nor spam-cans to worry about.

I glued the ferrite back together and splinted it with bits of wood too. Somebody had previously tried to stick it but had got one of the sections the wrong way 'round.

I found a resistor on the track side of the PCB which was broken in half and after changing that it worked. It would only get strong signals though and needed to be on full volume to be at a 'normal' listening level.

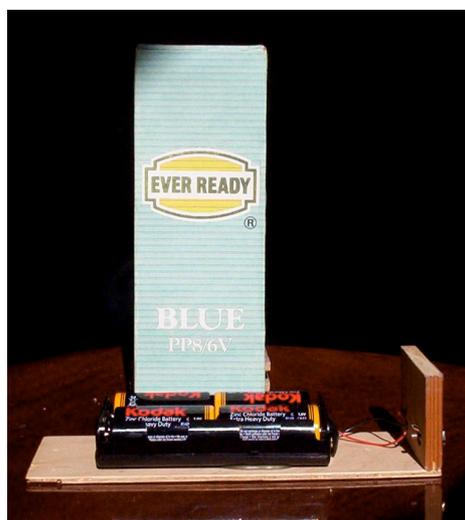
The effect of changing these was miraculous as it was now much more sensitive and plenty loud enough with the dial only just off the stop. I was so impressed that I even went to the trouble of making a replica battery for it. It was designed to use a 6V PP8 but these are no longer made so mine contains four HP11s.

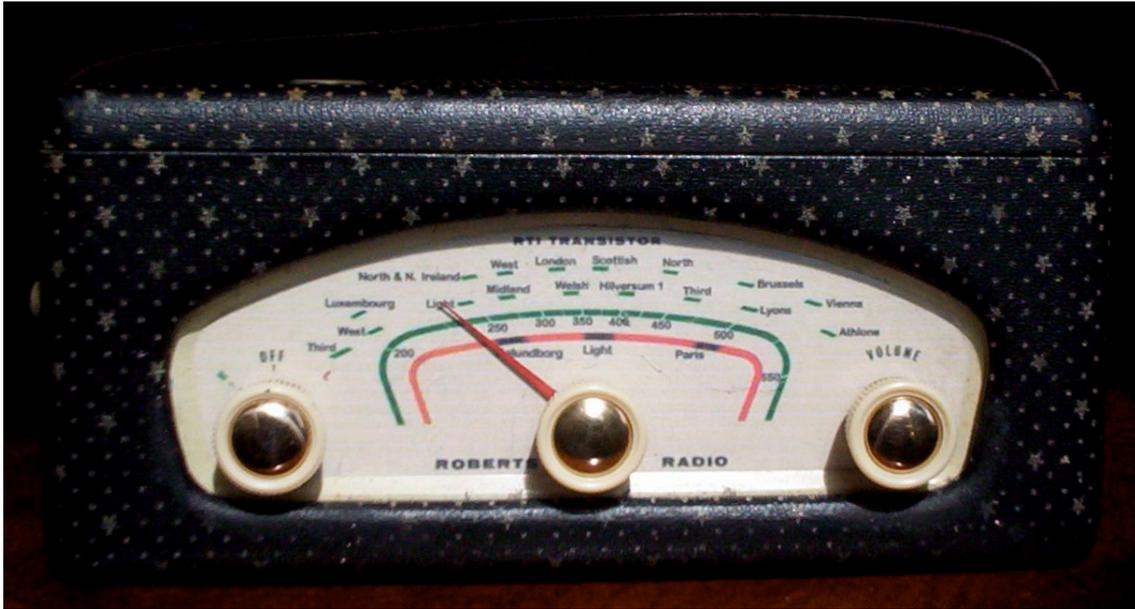
The dial was also badly scratched but I managed to get a scan off the internet which a friend further improved. I then printed this out and glued it over the original.

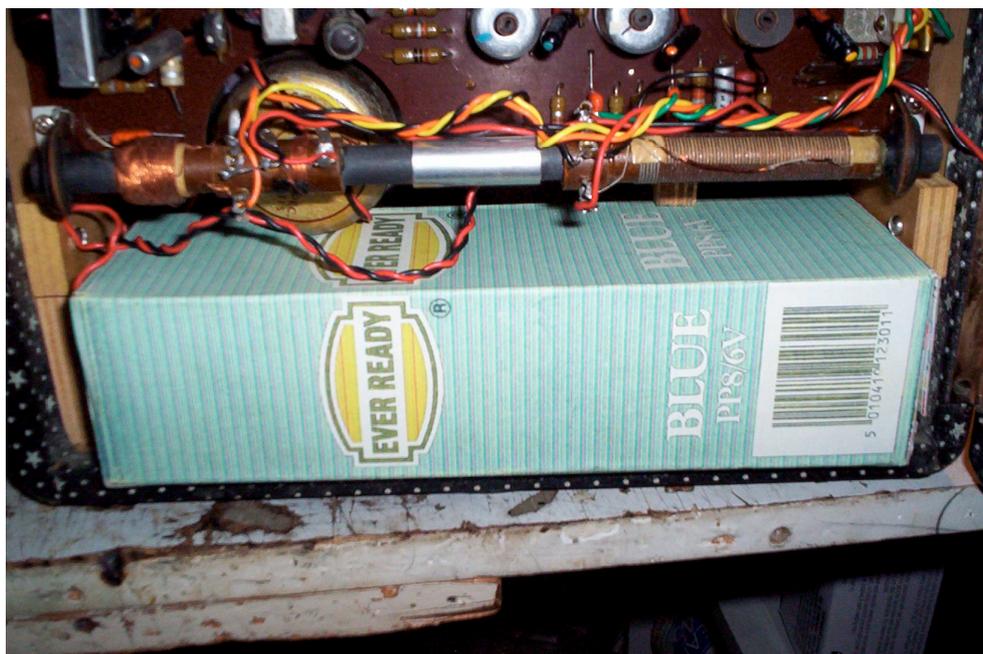
While I had it in bits again I made a better job of repairing the ferrite and it now gets regular use. It's handy for being portable and when it isn't worth warming a valve set up.

Following the "If in doubt blame a capacitor" rule I changed the two biggest electrolytics. All was now well, in fact better than it had been since I'd had it. One of these caps was the supply de-coupler so I bet it was that which was failing with an intermittent short circuit.
