# Bush DAC90

So far I've repaired four DAC90as (I own three) but have never managed to get hold of a DAC90.

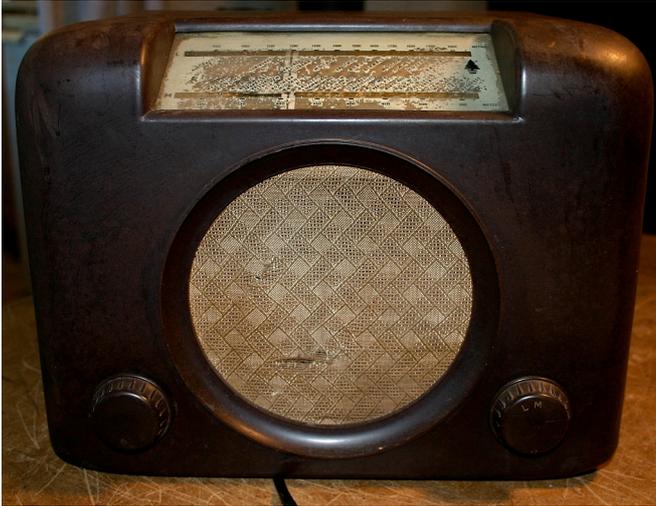
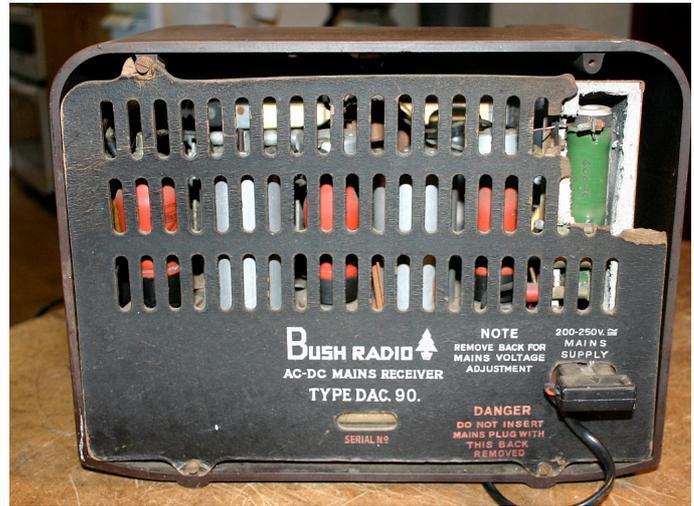
I eventually got one cheap off e-Bay as, as well as the usual hole burnt in the back, the white background of the dial was badly flaked.

It basically worked as it stood and even the controls weren't too dirty. Apart from a routine re-cap all that needed doing electronically was to replace/resleeve some dodgy wiring. Besides that I reconfigured the switch to work in the Live, as opposed to the Neutral, side of the mains.

The asbestos lining of the dropper housing looked a bit soft around the back edge but shellac stabilised it fine. This seemed like a less hazardous proceeding that removing it and replacing it with a modern alternative.

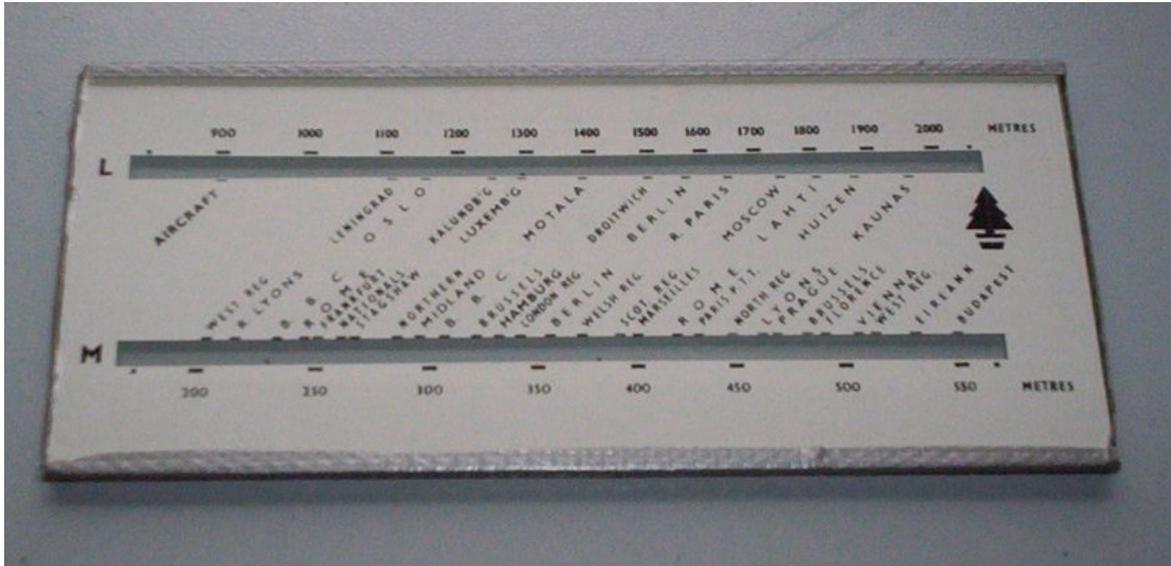
I had hoped that the rest of the dial background would come off without damaging the station markings but found that this wasn't a option.

I therefore scanned it, tarted it up on the computer and then printed it on paper. I sandwiched this between two bits of glass which made a very good substitute.

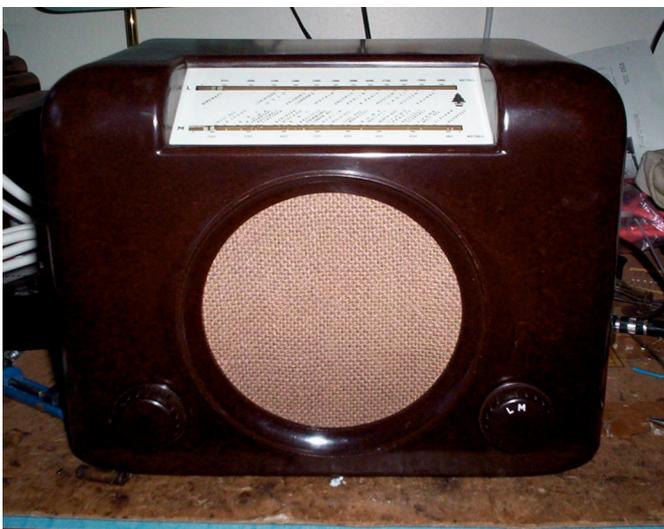
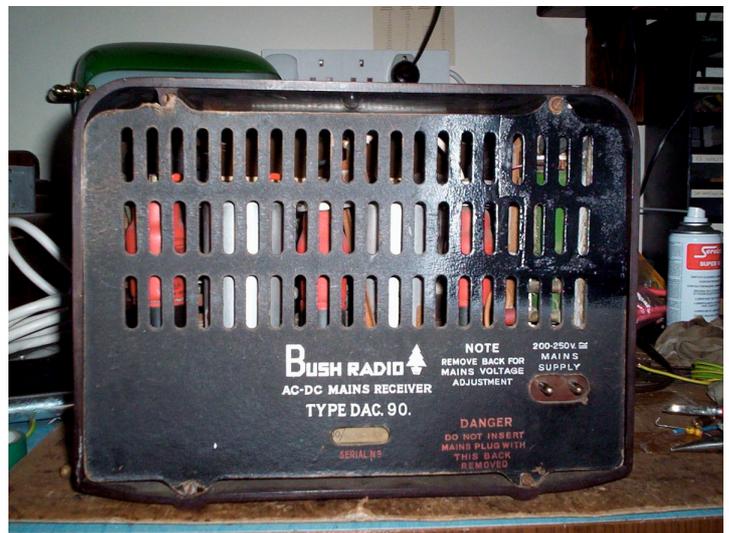
All told it's come up very well, and will improve with further polishing. As for performance it blows the 'as out of the water.

I left the original speaker cloth in place and stapled some hessian over it.
