# Ivory Bush DAC90a Restoration

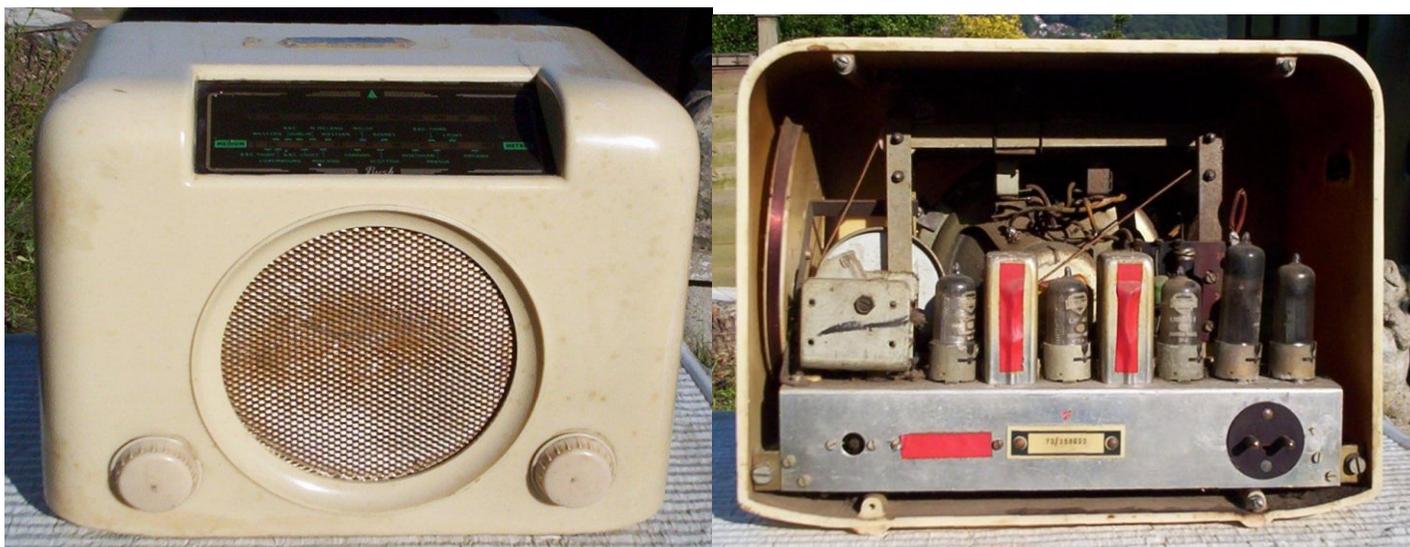
When it did arrive the case proved to be in disappointingly good condition which ruled out ideas I'd been having about customisation

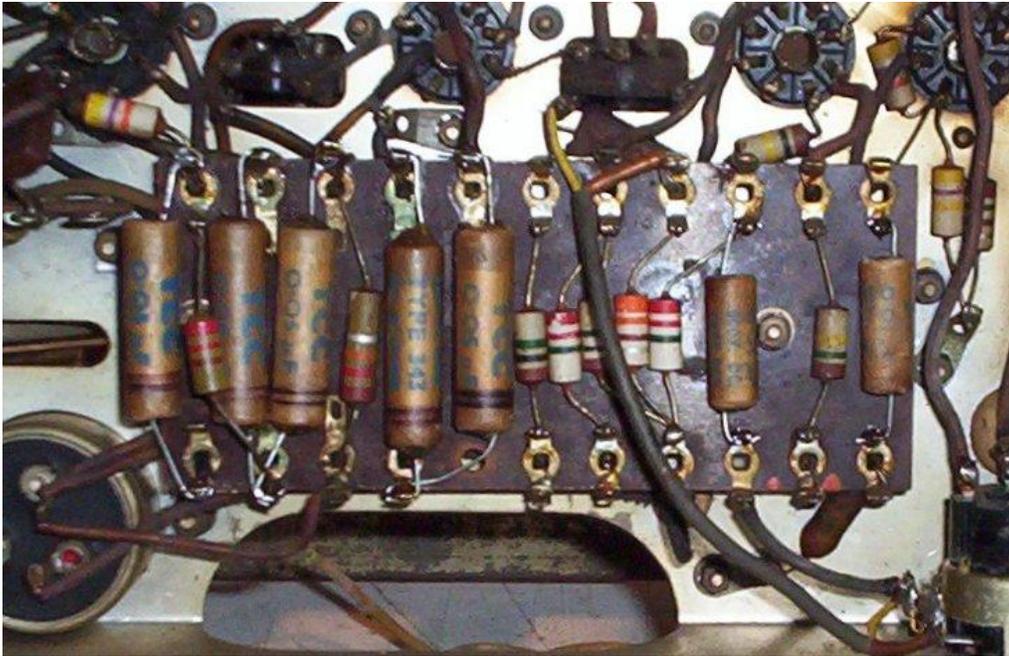
I then got on and re-capped it and went the whole hog by re-stuffing the old ones. This is something I've never seen the point of but found it quite enjoyable.

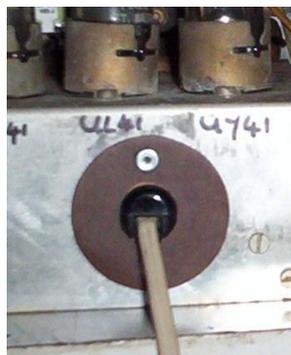
I now decided it was time to fit a proper mains lead. This was going well until the MW coil started to slip off the former. I managed to get it back and then gave it a coat of heavy shellac and had no further problems.

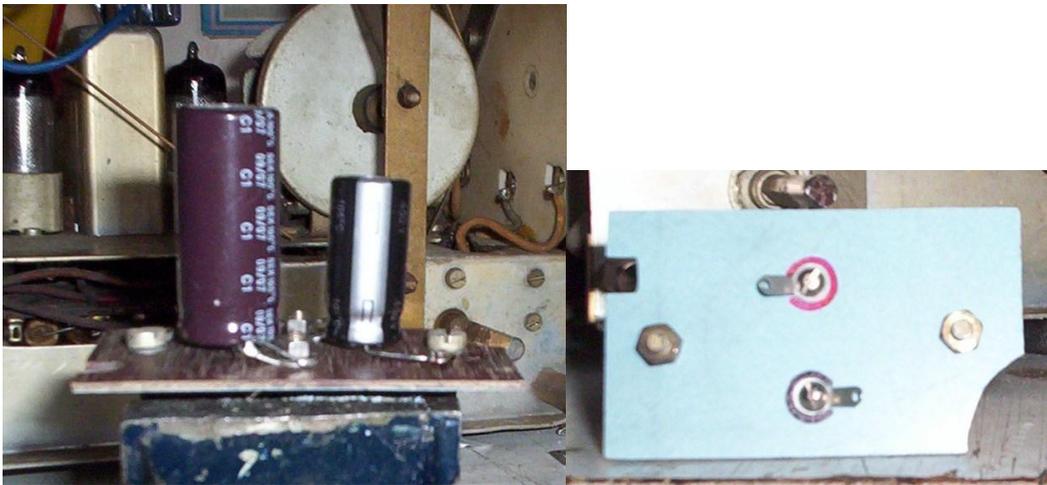
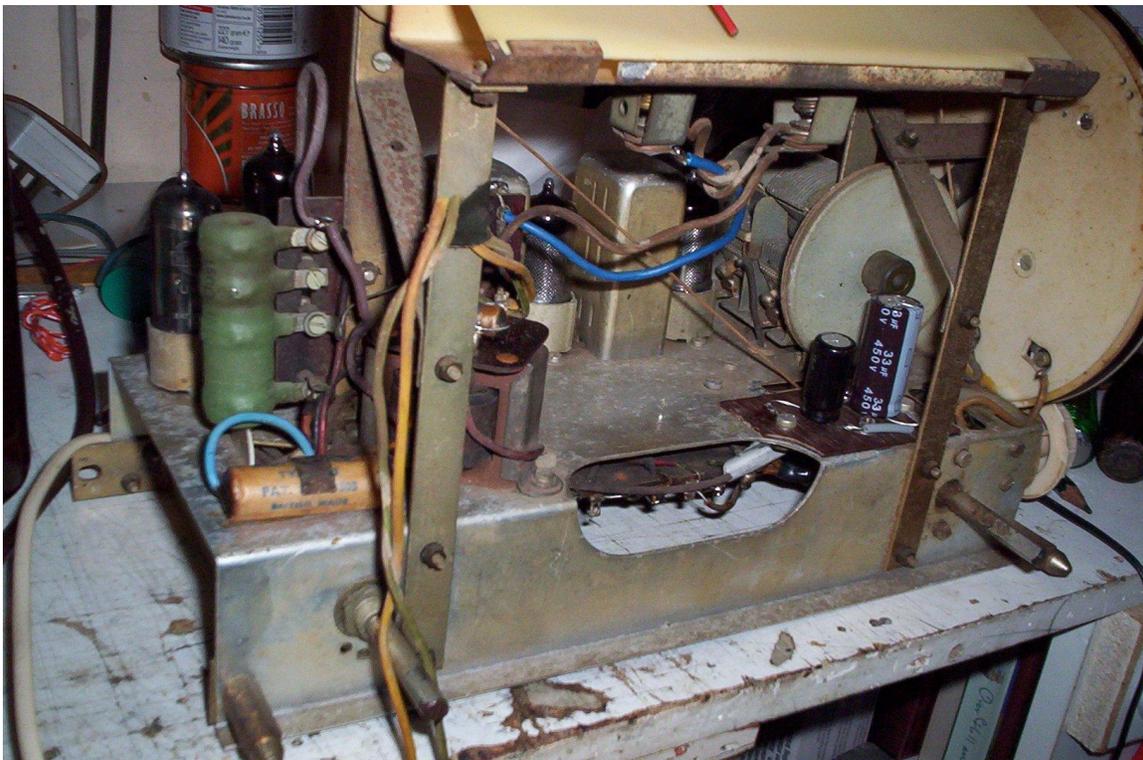
I put my trusty continuity tester across the smoothing cap and didn't like the sound of it. I

de-soldered it and tacked a new one in place and with that the HT was up to 190v, which was close enough for rock 'n' roll.

I connected the old one up via a 15W lamp and diode to see just what it was up to. It leaked about 7mA and the voltage across it never exceeded 280v. I left it for a bit to see if it would reform any better but after a while the leakage started to rise. It still felt cold but there was obviously something amiss with it. I also thought that it discharged rather quickly considering it was only connected to a DMM on volts.

Just for comparison I repeated this test with the new one. That leaked 0.5 am and the voltage went up to 345v (it was rated at 450v) and took far longer to discharge.

While I was at it I changed the reservoir too. I was still inexperienced enough to wonder if the original smoothing could be saved so I fitted the new ones on a piece of formica rather than restuffing it.

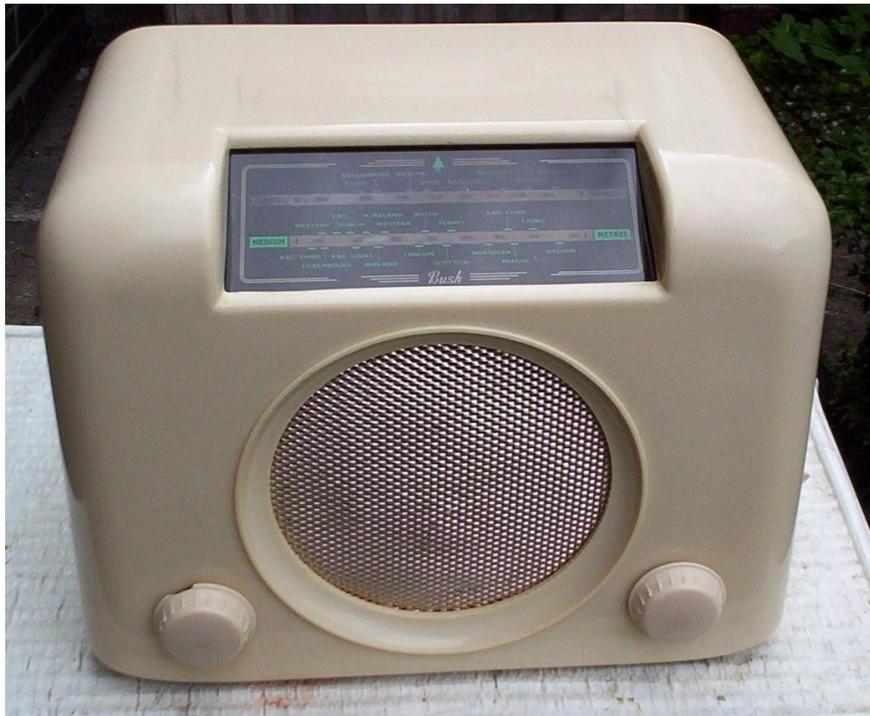
It wasn't long until I managed to get a pair of NOS UL41s for good price so that was it finished.

I did later have a proper go at reforming the original electrolytic can but it didn't want to play so I re-stuffed it.

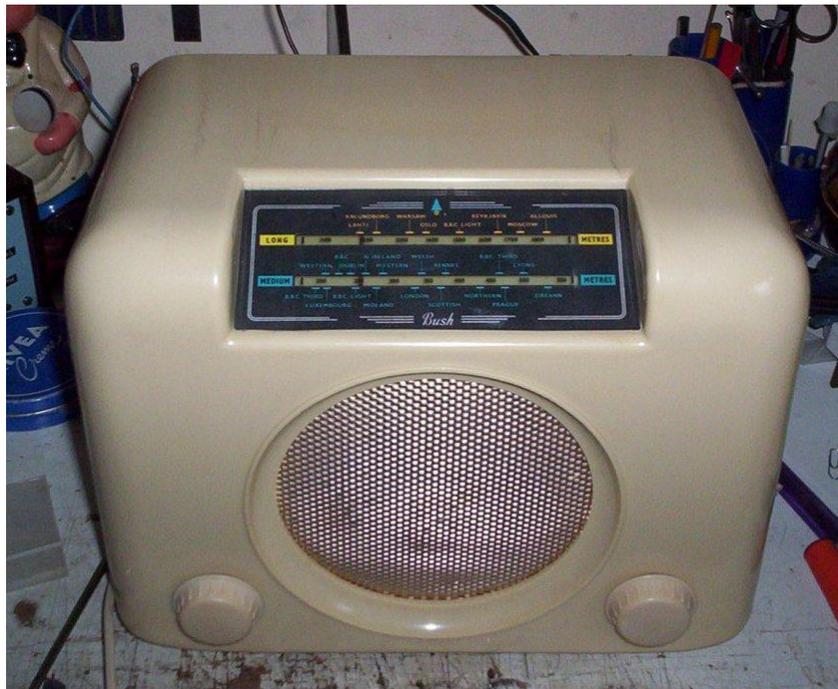
With no light behind it the new dial looked rather dark and, sadly, did so when lit as well — and this set had LEDs so was brighter than most DAC90as.

I got a mate with a colour printer to print out the dial artwork on paper in various colour schemes. The best looking was nothing like 'correct' but was far better than the old dial. I cut out the clear slots with the wave-lengths on and then put this paper in front of the acetate so the numbers on that showed through the paper. This arrangement worked fine.

A lot of people print replacements on water-slide transfer paper but I didn't have a colour printer. I then had the idea of getting it printed on acetate and then sandwiching that between two pieces of thin glass held together with gaffer tape as this would fit where the original rubber mounting channels had been.
