# ATM 232-Like Mine Telephone

This was one of those things that was simply too cheap to resist, coming in at a total of £22.50. It's an ATM T3903 from the 1930s which was used in the mining industry, though only above ground. Each of these telephones would have had its own battery and turning the magneto handle would have rung the bells on other telephones on the same circuit.

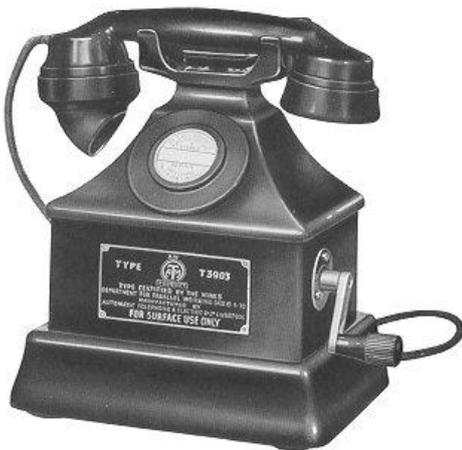
This is what it should look like:—

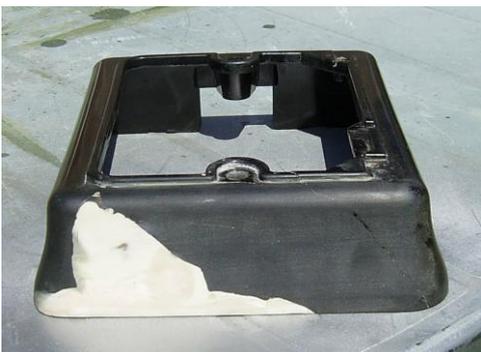
The biggest job would be repairing the bell cover. Part of it was broken off but still present as there was a screw passing through it but another section was long gone.

I superglued the broken part back which held it in place well enough to get some fibreglass behind it. I also used fibreglass to bridge the gap and then brought it up to level with Isopon P38 car filler. I could have attempted to stain this black but I know from experience that matching the colour is less than half the battle as fillers and substrates rarely polish to the same degree of shine. I therefore simply spray-painted the repaired side.

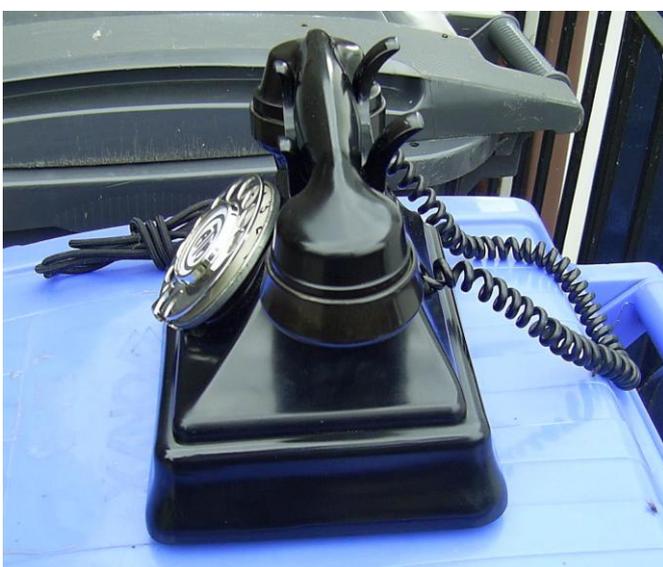
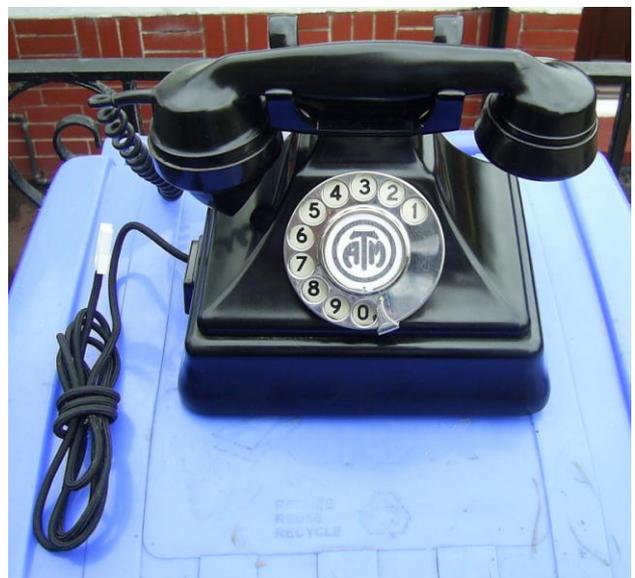
The line cord is actually a switchboard cord. You *can* get a BT plug 631A onto them if you're prepared to do immoral things with solid-core wire and superglue.

I was very happy with it until one day I received a 'phone call while I was upstairs and found that the 746 in my bedroom wasn't ringing properly. As the only thing I'd changed was having this ATM 'phone plugged in it was pretty obvious that that was the cause of the bother.

I'd got a spare 4,000 $\Omega$  bell motor so fitted that and everything worked together happily. The original coils are much thinner than normal so I suspect that for all that they have a DC resistance of 1,000 $\Omega$  their inductive reactance, and thereby their AC impedance, is lower. As ringing current is AC it's the latter that matters. It probably also explains why the motor wouldn't work at reduced current.
