Telephone Set J

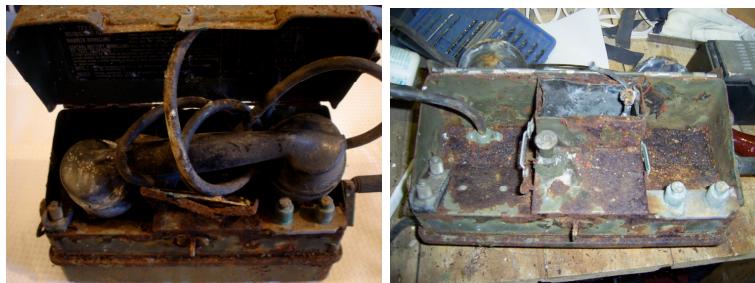
I bought this off e-Bay were it was described as being "In truly shocking condition" which was indeed the case.

The battery box was very badly rusted and contained an old bicycle lamp battery. All that remained of the lid was the rubber gasket with some lumps of rust stuck to it.

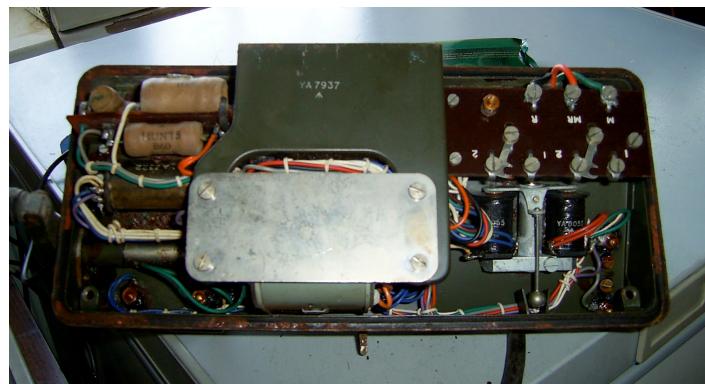
The insides looked much better.

For all that it worked I noticed that even with the Key down, which is effectively on-hook, the dial-tone was still there. In that state it should show an infinite DC resistance to the exchange but it actually measured about $50\text{k}\Omega$. Changing the capacitors fixed that. At first I thought the old ones were cased in some sort of ceramic but later concluded they were rubber which had gone rock-hard.

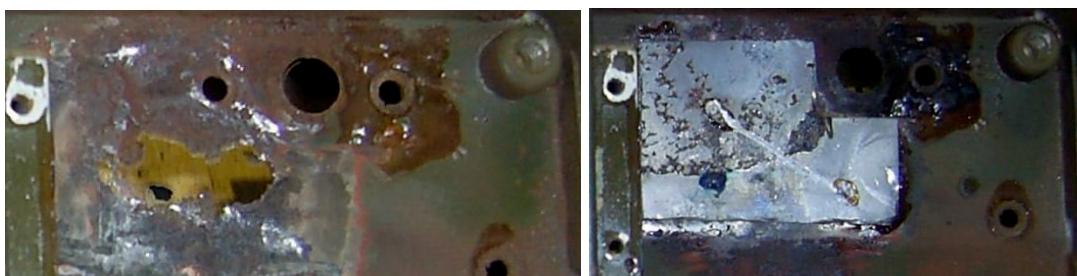
Apart from the battery box only one further hole appeared when I got the worst of the rust off and this was easy to patch.

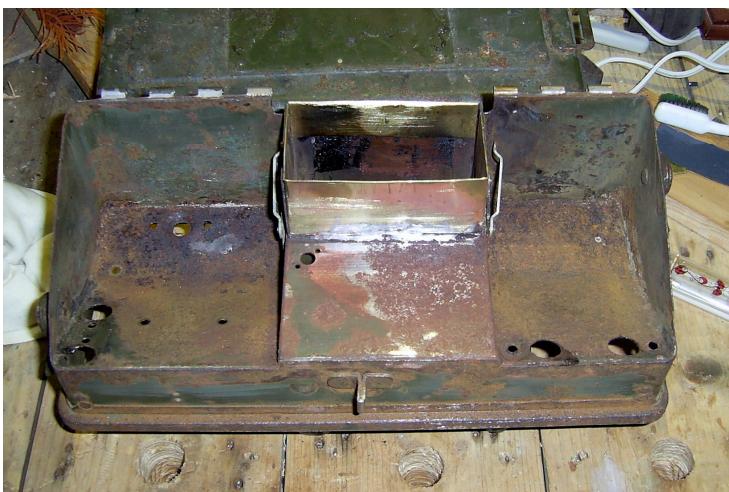
A lot of the rest was down to paper thickness so would be better filled than attempting to sand it smooth.

I decided to mend the battery box with brass as it's easier to work with than steel, and I'd got more of it.

I cut away the front part of the original and soldered a piece of brass to the inside of the sides — in the case of the right hand side what remained of it.

The back was alright apart from at the top so I cut that off and replaced it with a bit of brass doubled over to stiffen it.

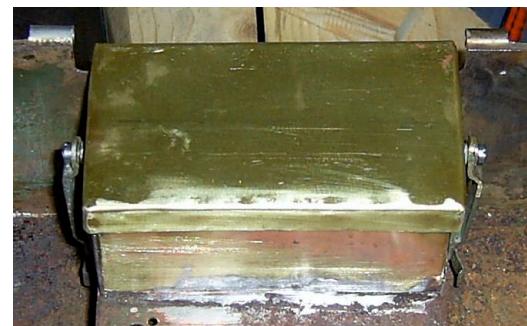
The bit I'd expected to be most difficult was making a new lid for the battery box. In the event this went very smoothly, probably because I didn't measure anything — "Measurement is the enemy of Accuracy" after all. I again used brass.

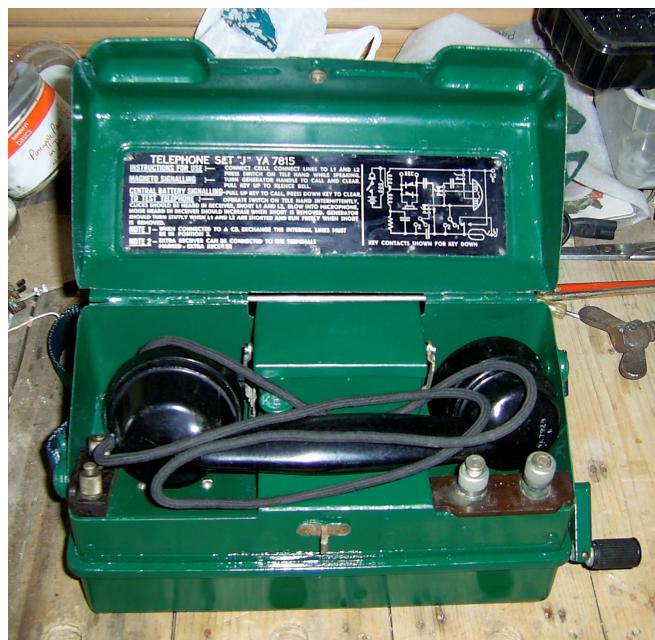
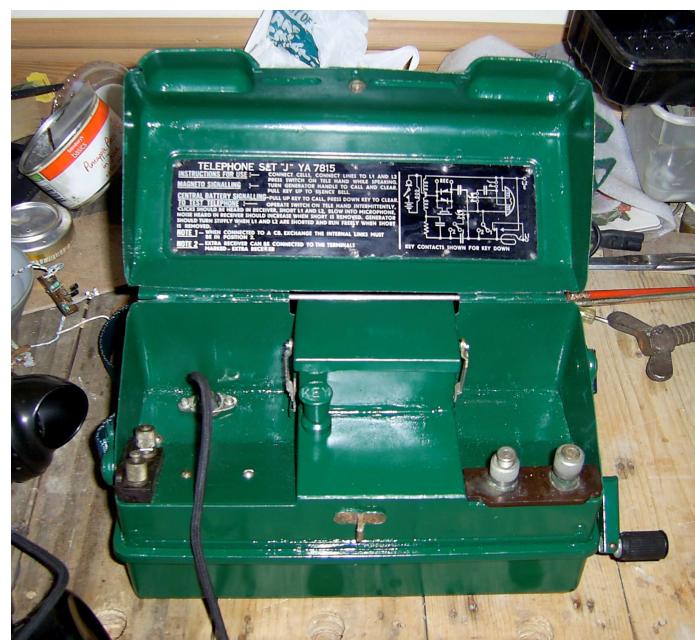
That was the end of the structural repairs and after that it was a case of filling the rusty plating and then painting it. I couldn't get the correct colour paint, or not at a vaguely sane price at least, but got some that I like; it looks far nicer in the flesh than on these photographs. This 'phone hasn't much historical value as all the internal wiring is PVC so it must have been re-newed at some time. These 'phones remained in use by Civil Defence until its abolition in 1968.

It's still far from perfect but looking like it's been kicked 'round a battle-field isn't altogether inappropriate.

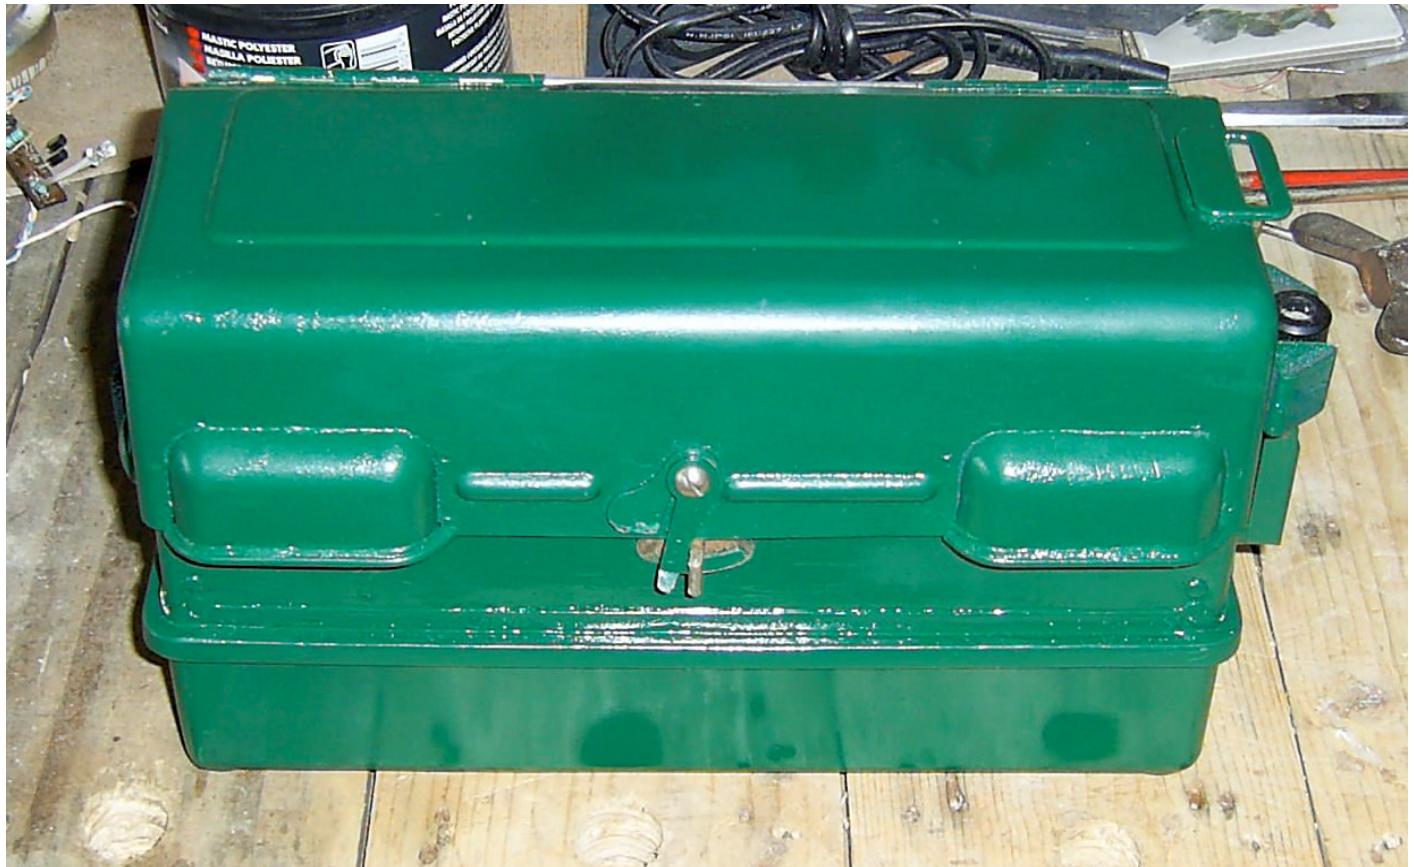
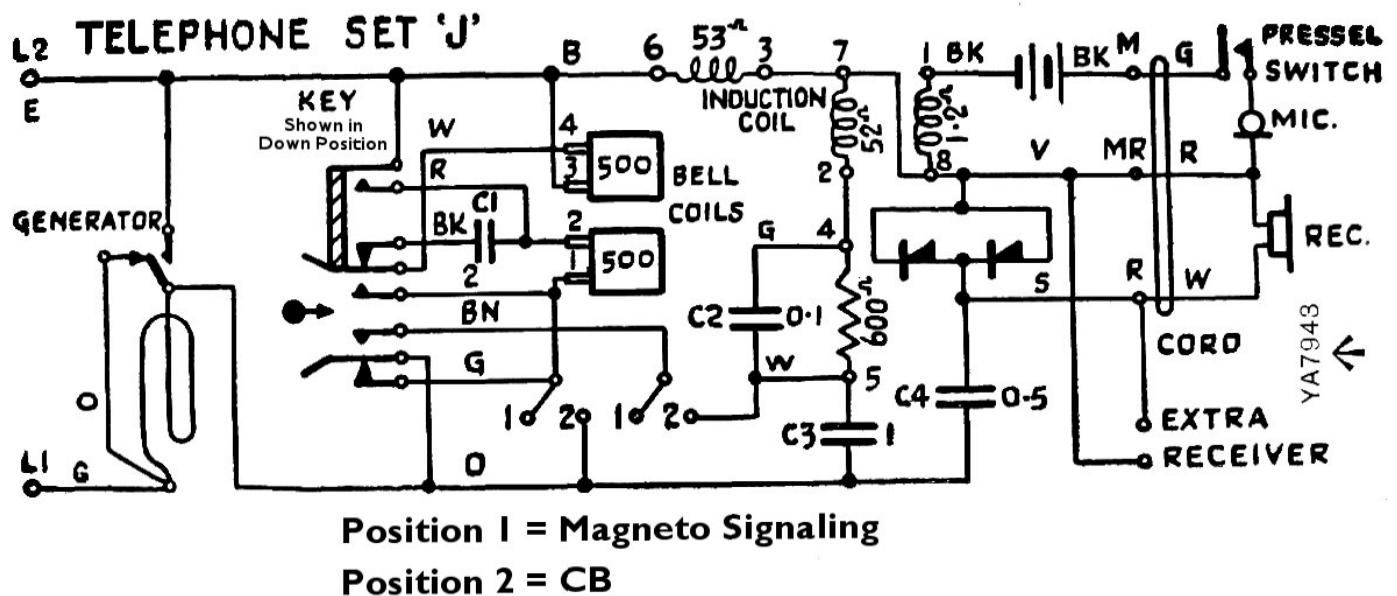
One interesting thing I found is that despite having two 500Ω bell coils, as do most 'Vintage' telephones, it was an absolute hog for ringing current; it would ring OK but not leave any for any other telephones. Instead of fitting the usual $3.3k\Omega$ limiting resistor I found that $5.6k\Omega$ worked better. This not only left current for the others but improved the sound of the J. It doesn't have actual bells; the hammer hits the case and reducing the force of this certainly made the sound more pleasing.
