An Un-Natural Union Between a 232 and a 746

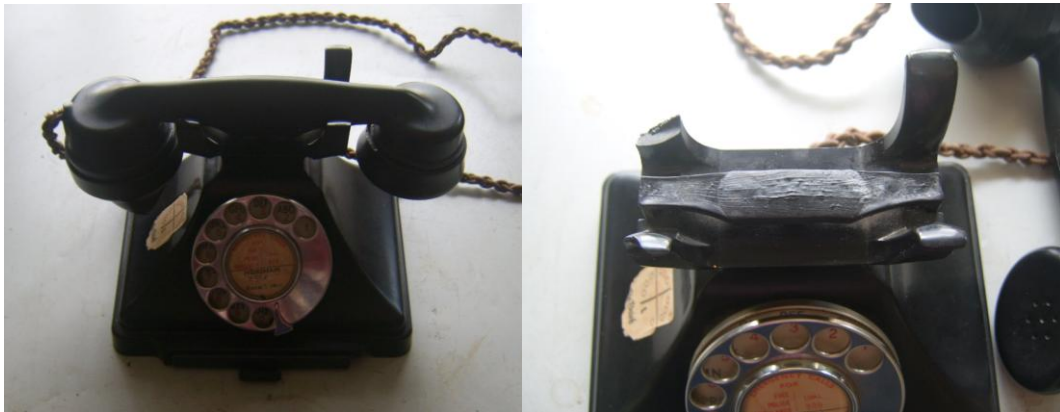
When arrived it had more damage than had been declared. As well as the broken 'horn,' which had been mentioned in the listing, there was a chip out of the base, a fag burn in the celluloid drawer pouch and the earpiece had a small nibble out. The 'tee bar' seemed to have simply degraded and become extremely brittle. Inside the induction coil and all wiring was AWOL. The dial was very stiff but that was an easy fix as it wasn't damaged, just in need of servicing. All the terminal screws had been nicked though.

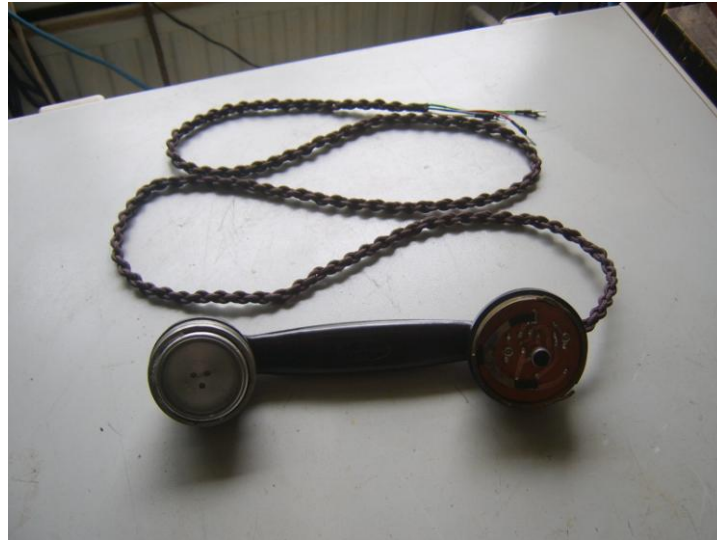
The circuit of the 746, and the 706 before it, differs in that the handset is connected with a four- as opposed to three-core cord. The receiver also has a lower resistance. I don't know if that would matter in the real world as for all that the RESISTANCE is lower I don't know about the IMPEDANCE. This 'phone had one of the early No 1L receivers. These are appalling: they sound so tinny that they nearly loosen your fillings. The GPO came out with a better version, the 2P, during the 1950s which are as good as anything that's been made since. However to get the best out of one of those you really need to change the earpiece as well, from a No 18 to a No 23. What I did was remove the guts of the 1L and put a 700-series 4T inside it.

The correct induction coil for this would be a No 27. These are easily available and not too expensive but I decided to have some fun and fit a No 32 as used in the much later 746. I had to make a PCB to mount this which took a bit of working out how best to squeeze it in.
