# Bush VHF90 Restoration

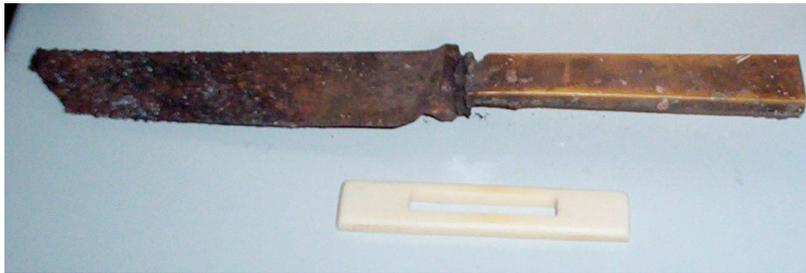
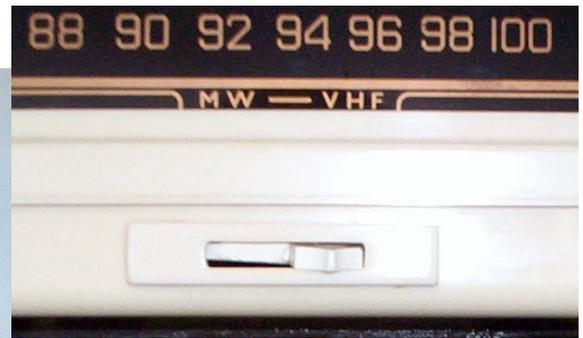
The set was in good nick cosmetically. The only thing wrong in that regard was the escutcheon around the wave switch being missing but I made a new one out of an old ivory knife handle.
